# INSPECTION REPORT

For the Property at:  
**ST ELSE WHERE**  
COOL STREAM, AB

Prepared for: JOHN AND JANE DOE  
Inspection Date: Friday, April 1, 2011  
Prepared by: Kevin Lester

**KL HOME  
INSPECTIONS LTD.**

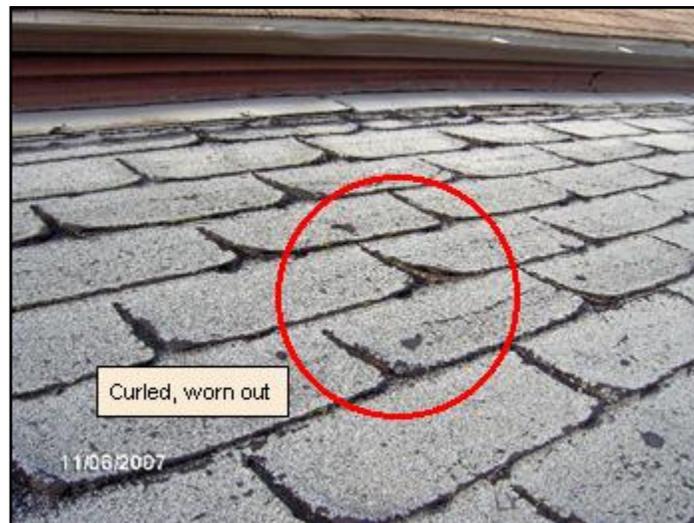
**Condition:** • Cupping, curling, clawing

**Implication(s):** Chance of water damage to contents, finishes and/or structure

*Shingles are curled on this side of roof*

**Task:** Replace

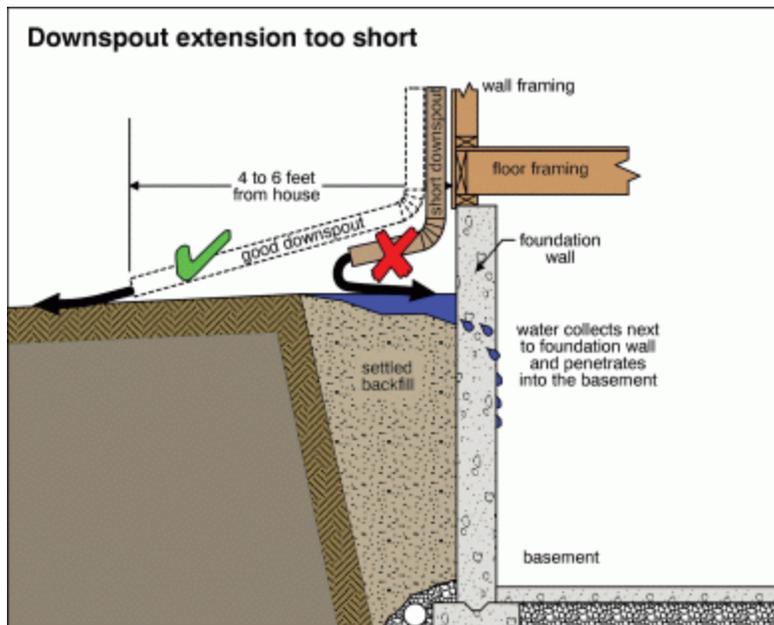
## Downspout extension too short

**Condition:** • Downspouts end too close to building  
Extend this downspout to six ft to keep water out of garden area.  
**Implication(s):** Chance of water damage to contents, finishes and/or structure  
**Location:** East Exterior  
**Task:** Improve  
**Time:** Less than 1 year  
**Cost:** Minor

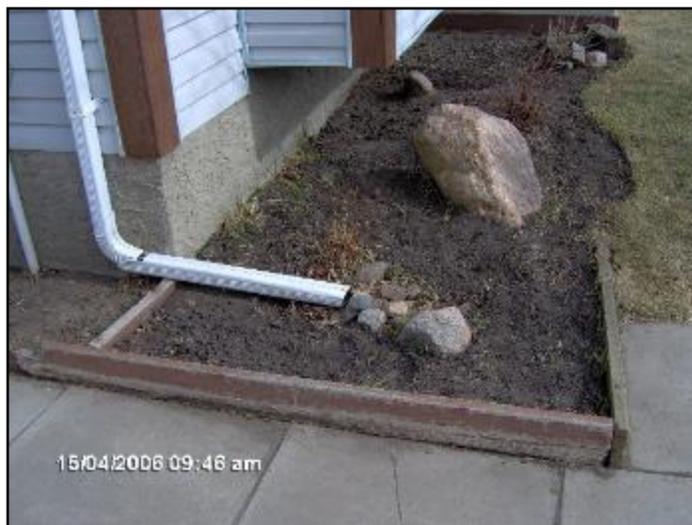
*Extend 6 feet minimum.*

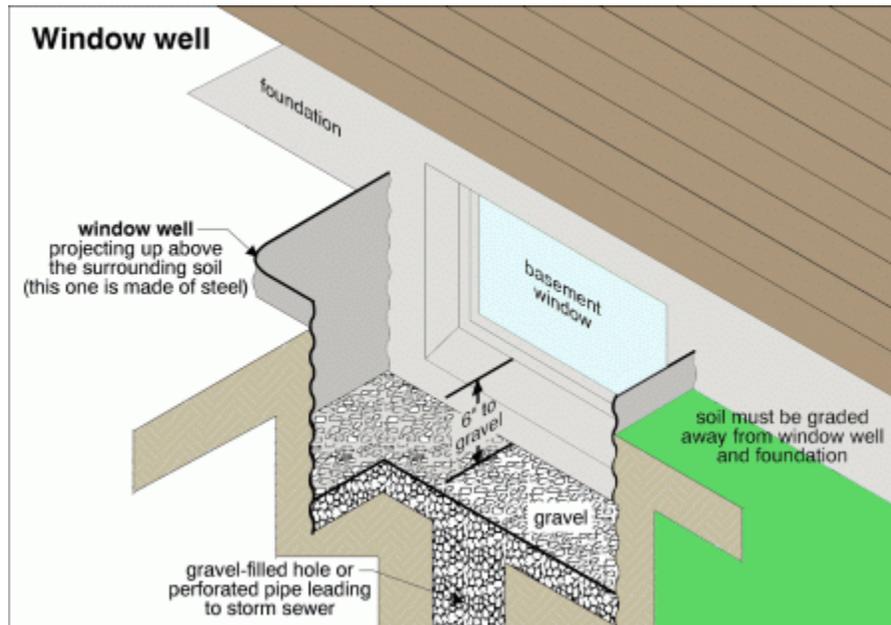
**Condition:** • Missing

**Implication(s):** Chance of water damage to contents, finishes and/or structure | Material deterioration

**Task:** Provide

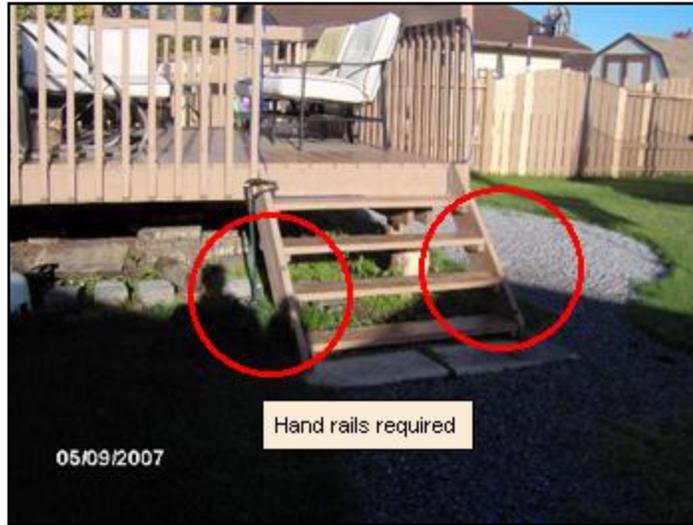
**Condition:** • Missing

Rear deck

**Implication(s):** Fall hazard

**Task:** Provide

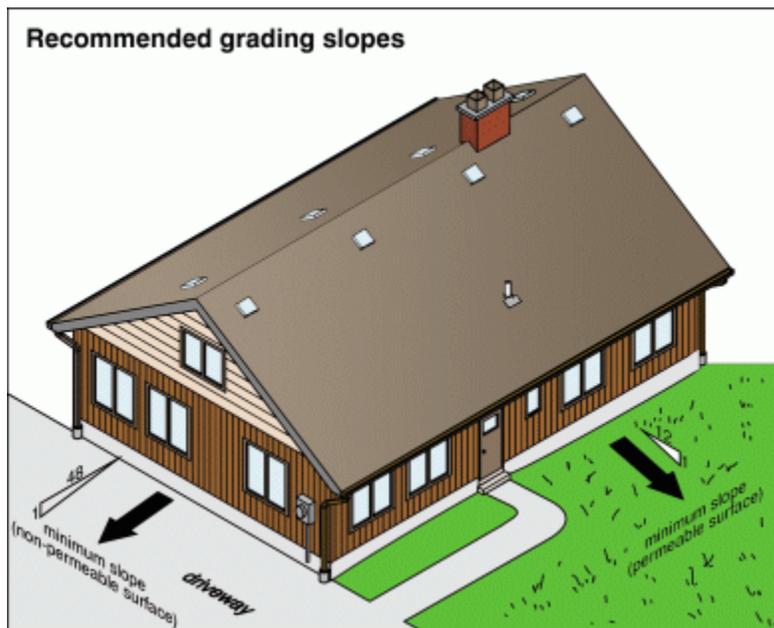
**Condition:** • Improper slope

Watch these areas for water build-up. Consider regrading away from house if water remains in low areas.

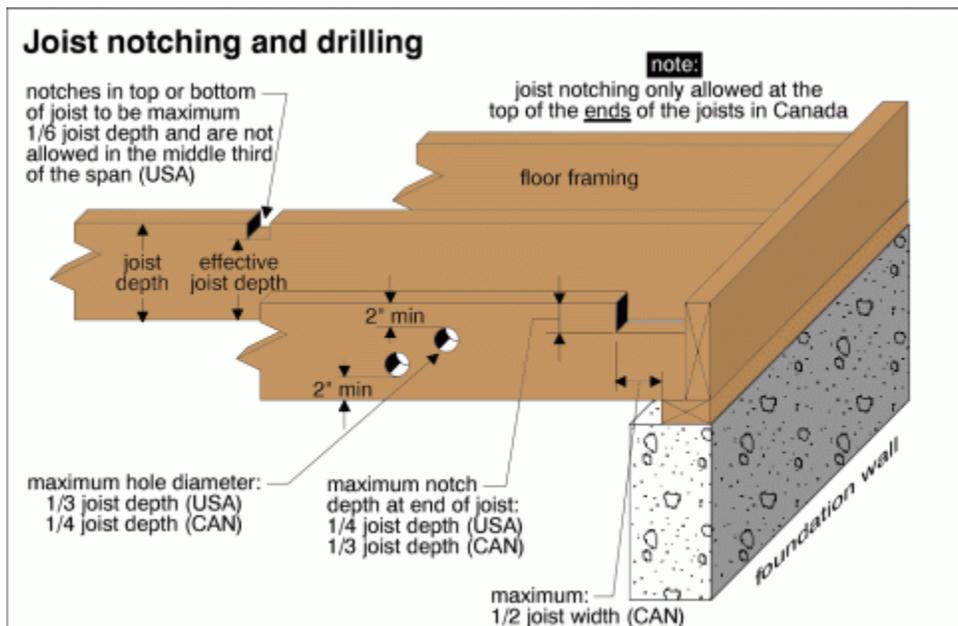
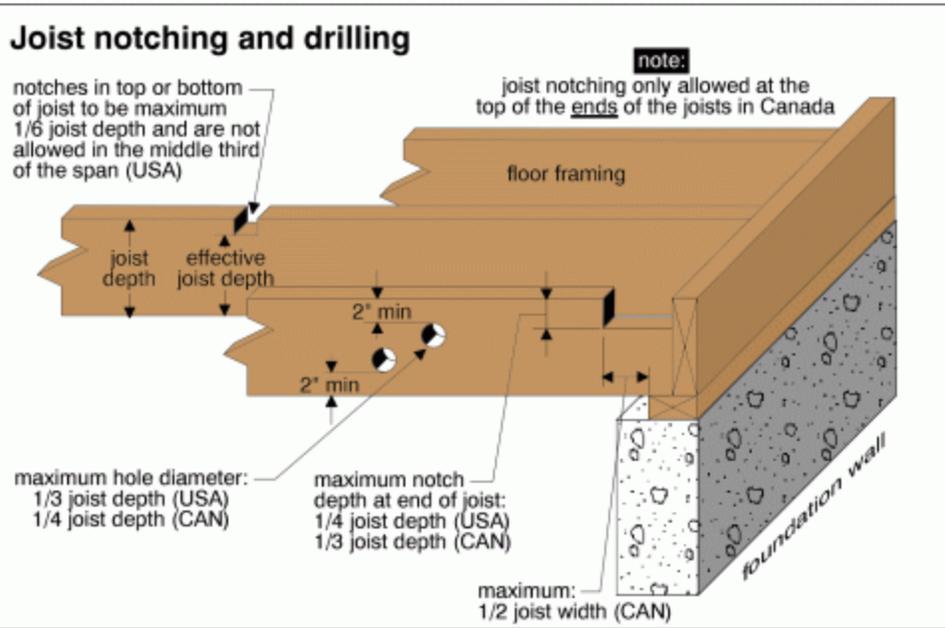
- Condition:** • Notches or holes
- Implication(s):** Weakened structure
- Location:** Basement Utility room
- Task:** Improve
- Time:** Less than 1 year
- Cost:** Depends on work needed

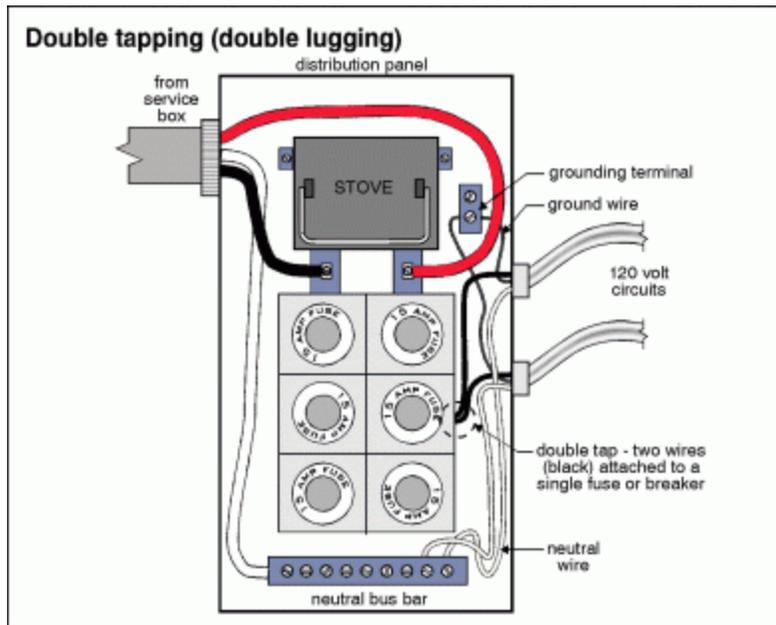
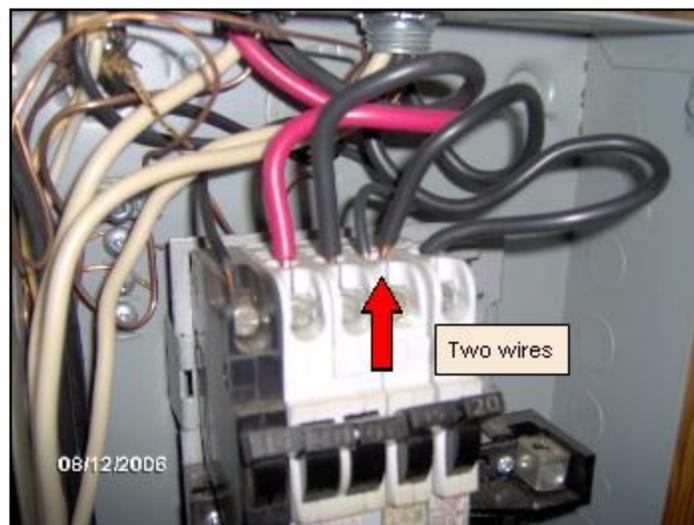
**Condition:** • Double taps

**Implication(s):** Fire hazard

*Two wires in one breaker*

**Task:** Correct

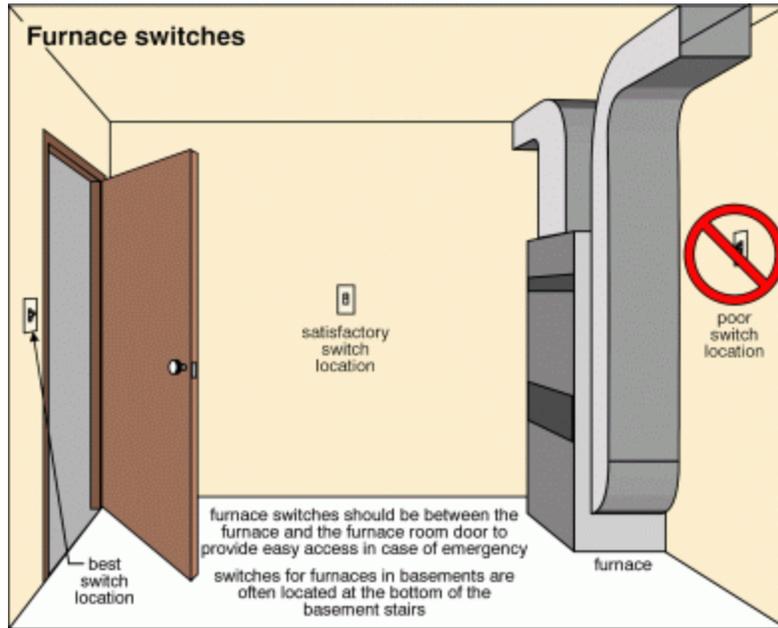
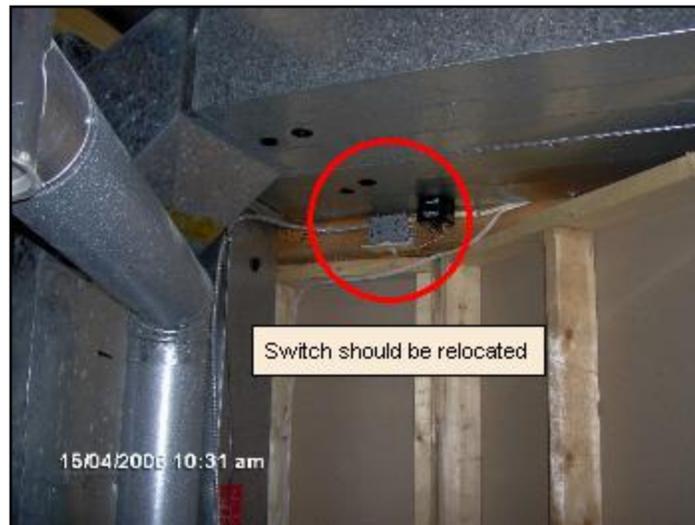
**Condition:** • Poor location at furnace

Access to switch is too far from utility entrance. Relocate closer to door and have switch between furnace and door.

*Locate between door and furnace.*

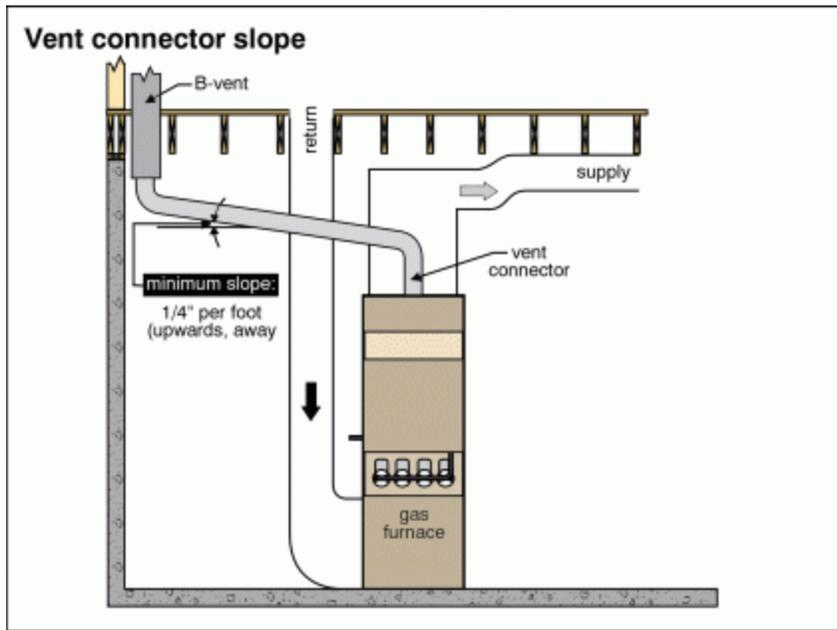
**Condition:** • Cracks, holes or rust

Heat exchanger rusted. Have gas company verify heat exchanger integrity.

**Condition:** • Poor slope

**Implication(s):** Equipment not operating properly | Hazardous combustion products entering home

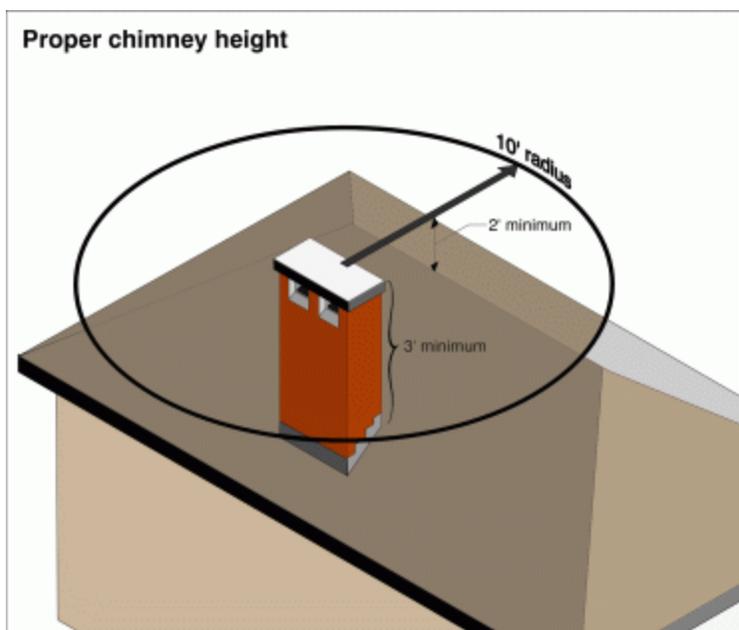
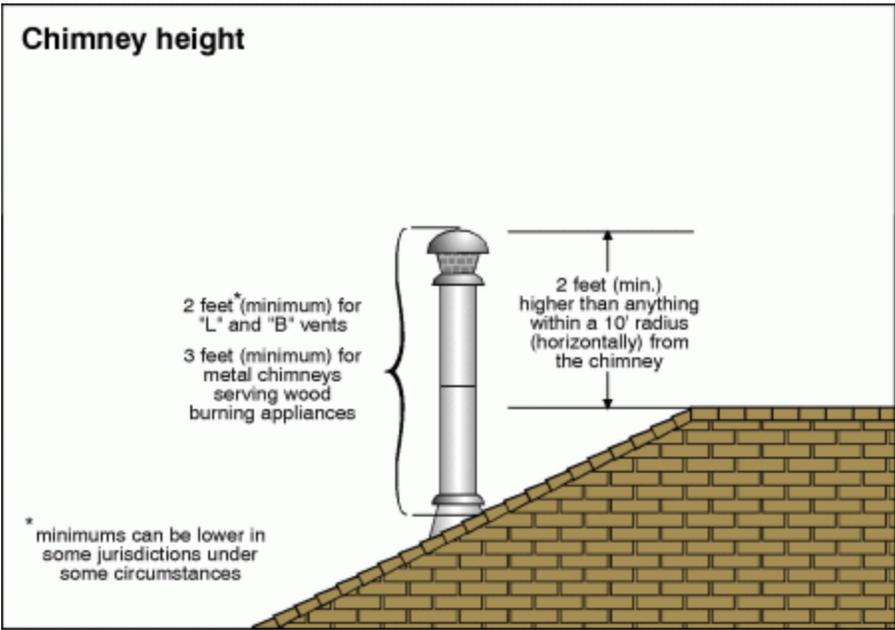
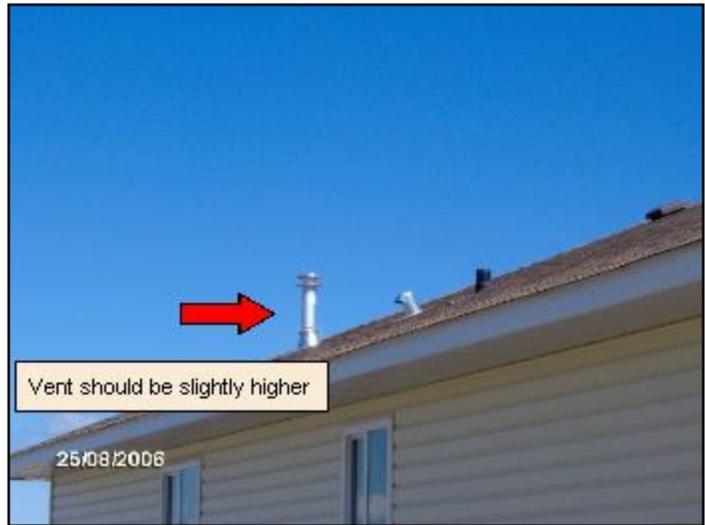
**Condition:** • Inadequate chimney height above roof

**Implication(s):** Equipment not operating properly | Hazardous combustion products entering home

*Chimney should be higher*

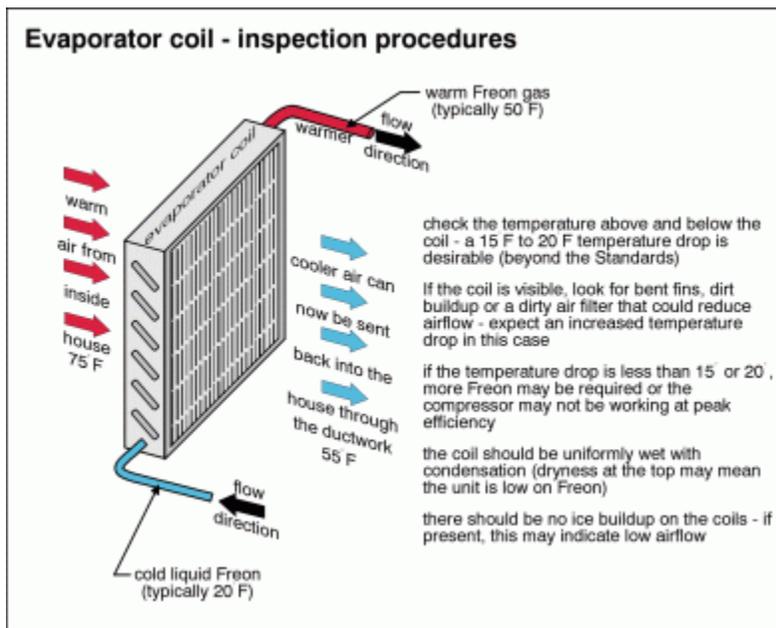
**Condition:** • Frost

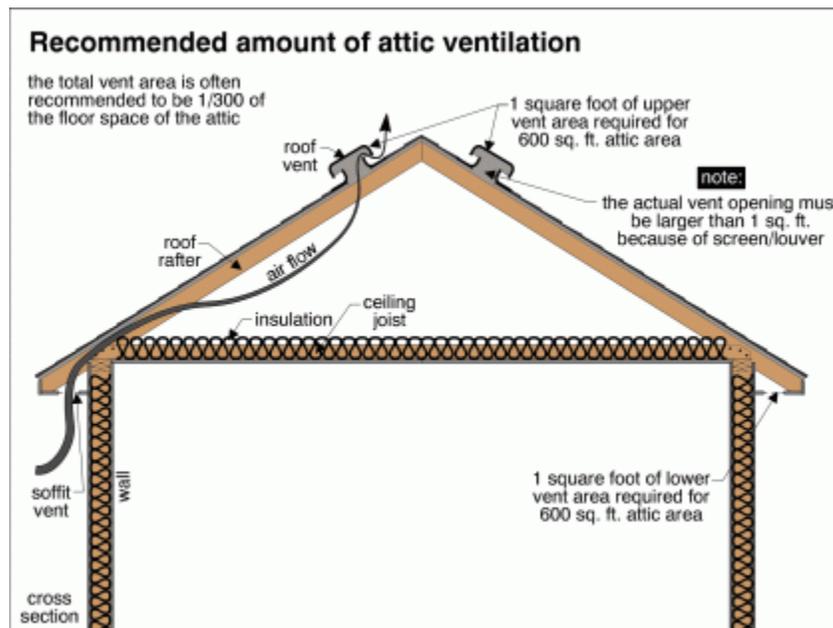
**Condition:** • Inadequate

**Implication(s):** Chance of condensation damage to finishes and/or structure

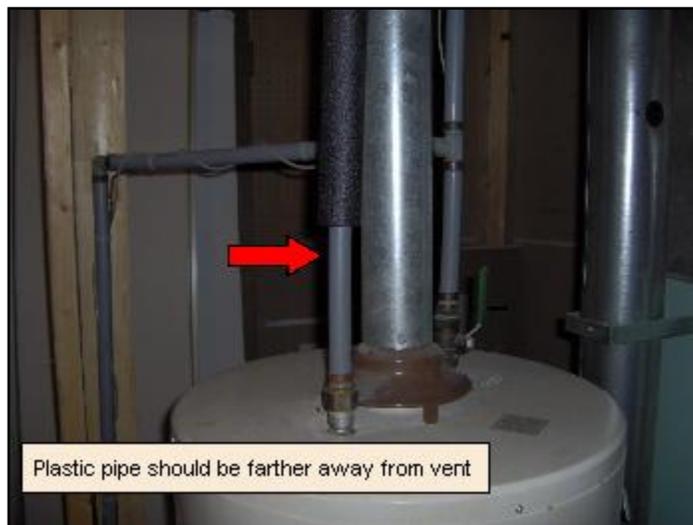
**Condition:** • Polybutylene at water heater

**Implication(s):** Chance of water damage to contents, finishes and/or structure

*Plastic pipe at the water heater*

**Task:** Repair or replace

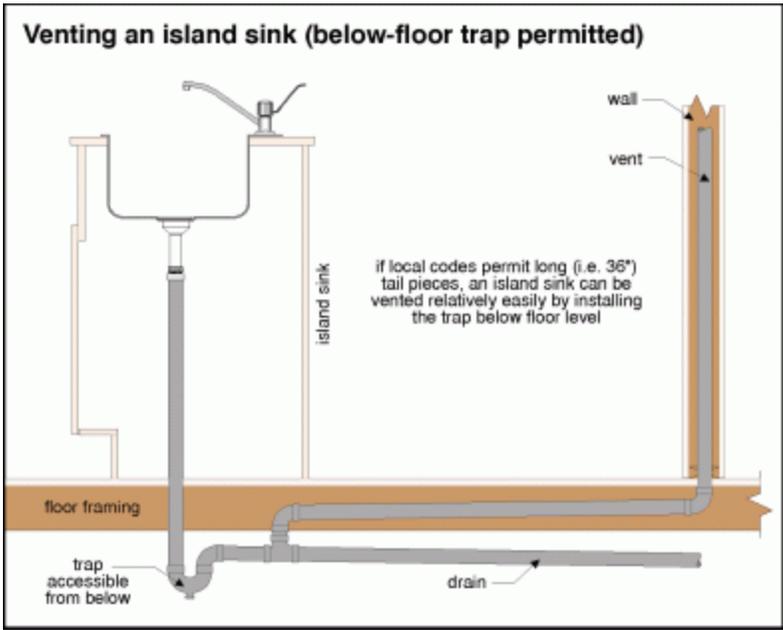
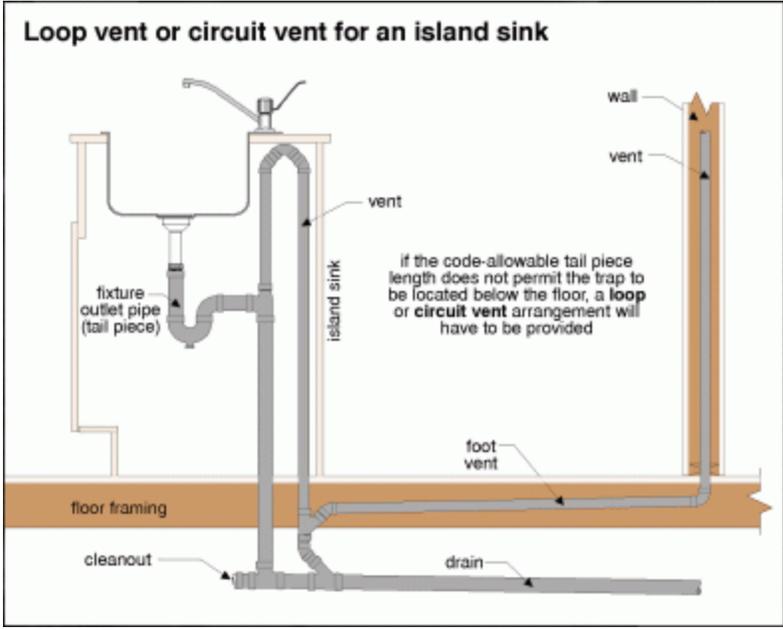
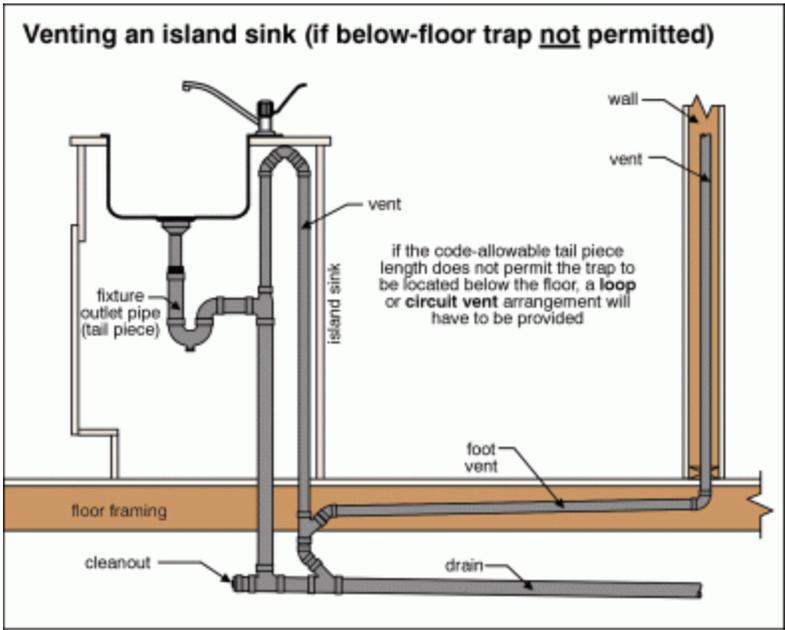
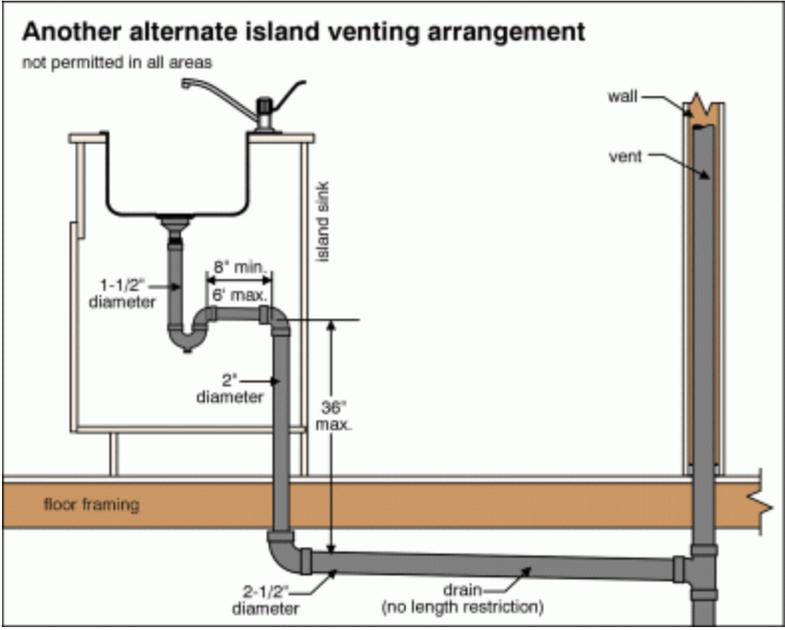
**Condition:** • Island venting problems

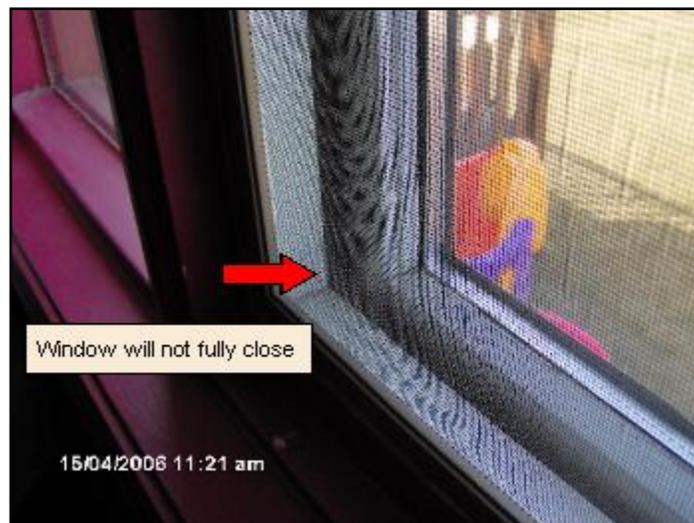
**Condition:** • Inoperable

*Window will not close to enable lock*

**Task:** Repair

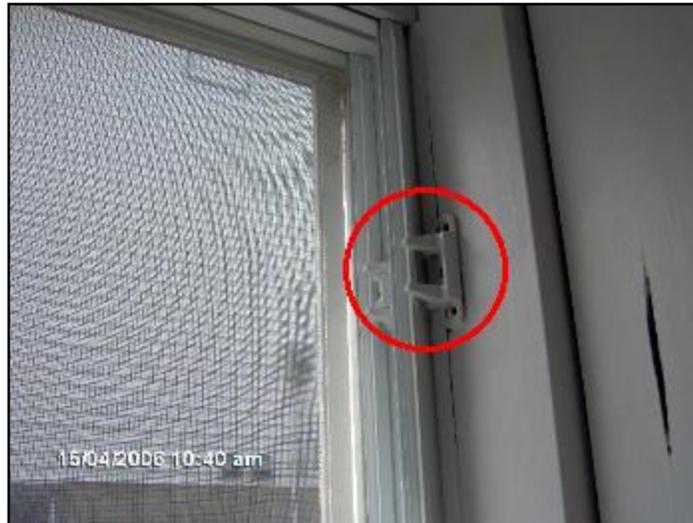
**Condition:** • Broken

*Lock mech. broken - no security.*

**Task:** Repair

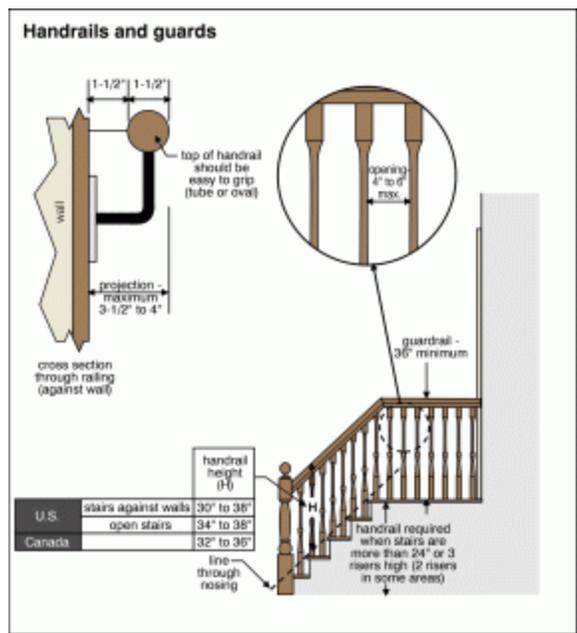
**Condition:** • Too low

**Implication(s):** Fall hazard

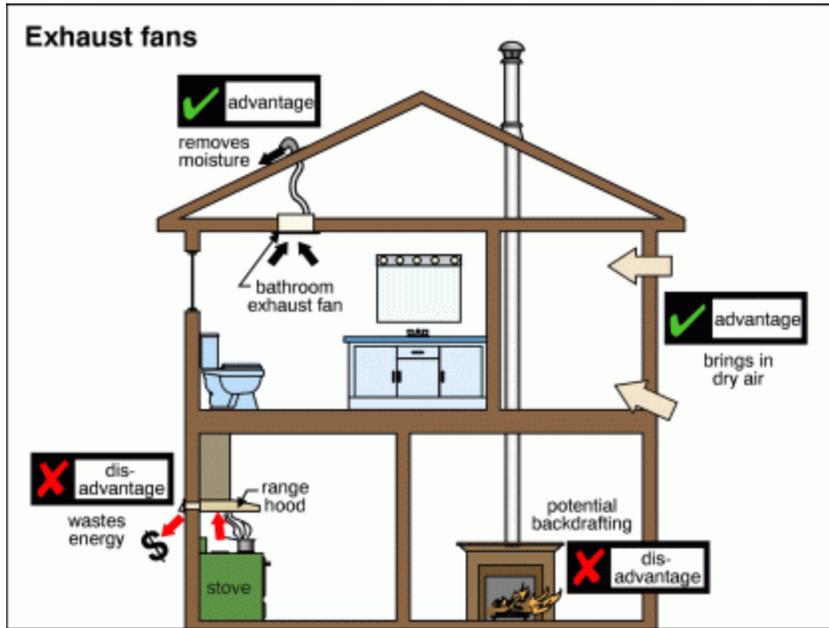
**Condition:** • Missing

**Implication(s):** Chance of condensation damage to finishes and/or structure
