# INSPECTION REPORT

For the Property at:  
**ST ELSE WHERE**  
COOL STREAM, AB

Prepared for: JOHN AND JANE DOE  
Inspection Date: Friday, April 1, 2011  
Prepared by: Kevin Lester

**KL HOME  
INSPECTIONS LTD.**

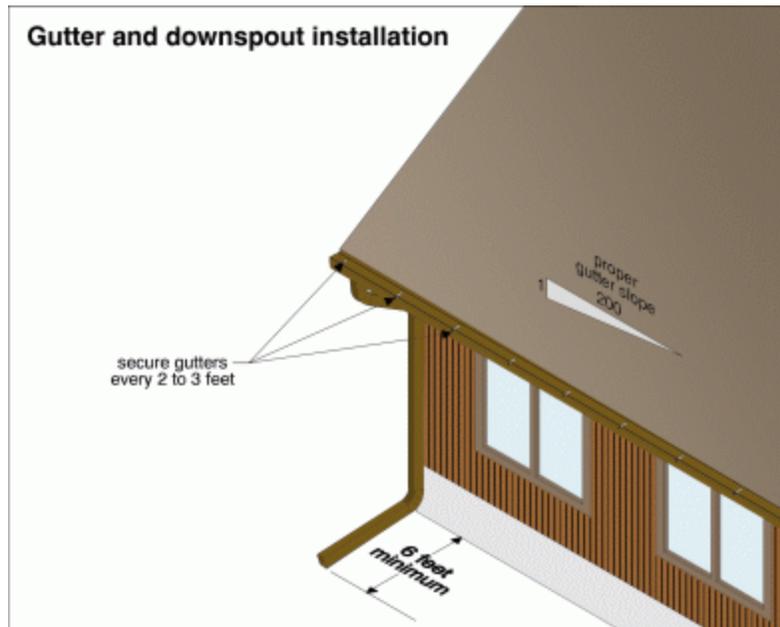
## Gutter and downspout installation

**Condition:** • Downspouts end too close to building  
Extend this downspout to six ft to keep water out of garden area.  
**Implication(s):** Chance of water damage to contents, finishes and/or structure  
**Location:** East Exterior  
**Task:** Improve  
**Time:** Less than 1 year  
**Cost:** Minor
